POLLOK COUNTRY PARK

MANAGEMENT PLAN 2011 - 2016

POLLOK OLD STABLES STANDING BUILDING SURVEY
PREPARED BY:

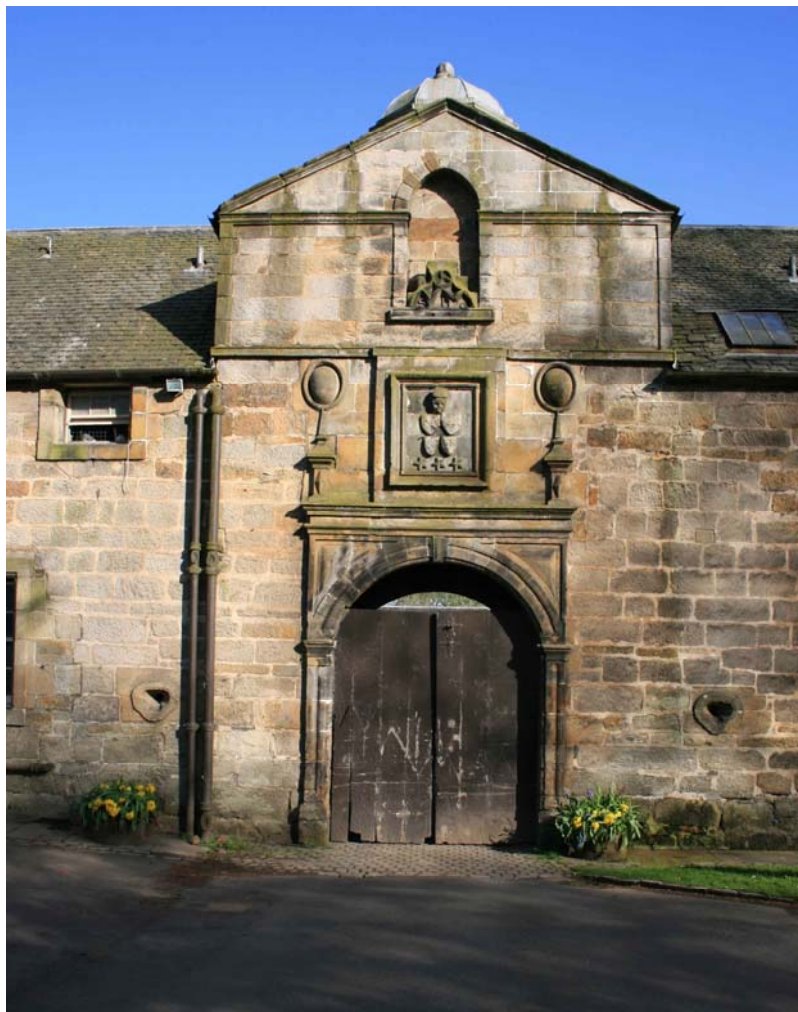
External view of Gateway Entrance.

The gatehouse leading into the Stables is a fine example of Renaissance architecture. The development of this building also shows a variety of architectural styles within its fabric. Figure 1 shows several of these features including a 17th century surround to the gateway which is partly overlaid upon an earlier facade.

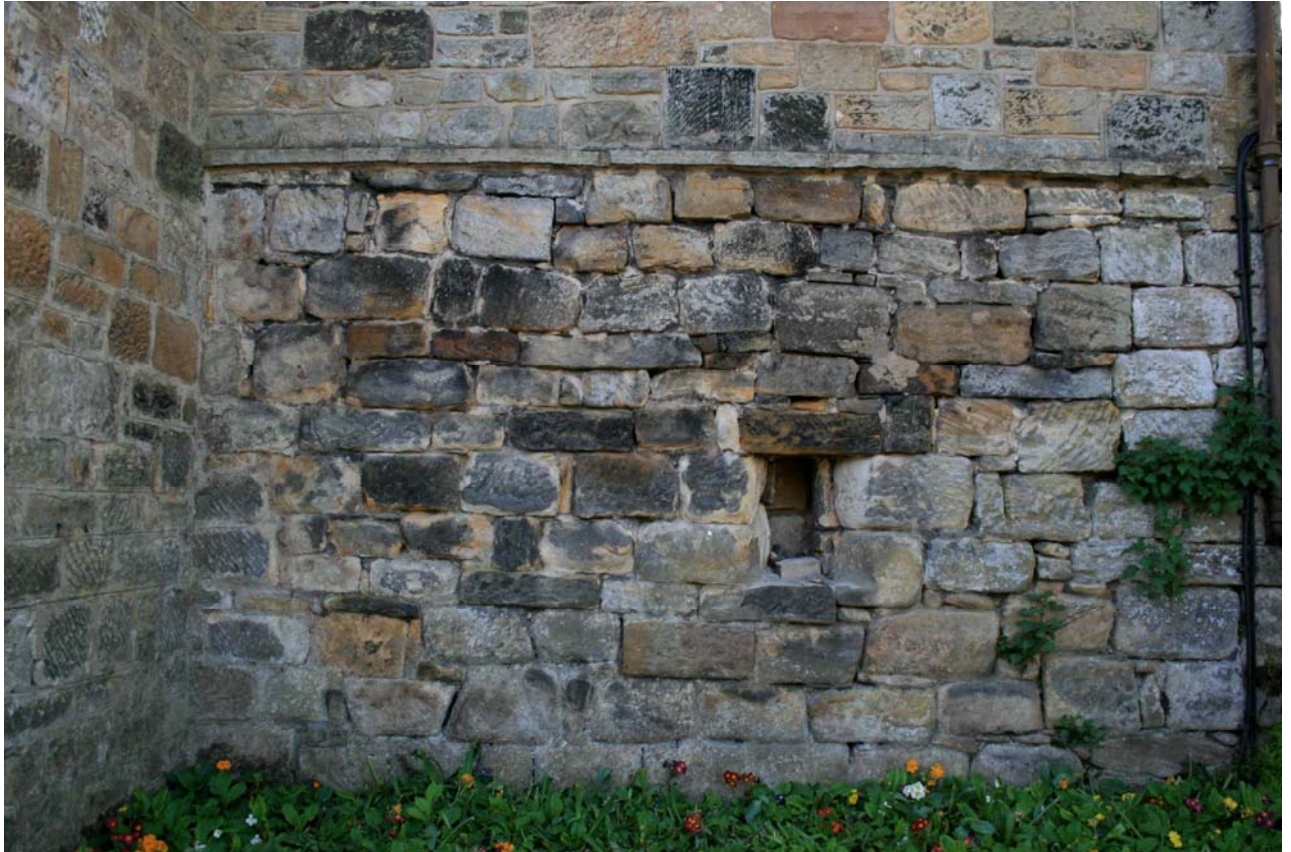
Figure 2
14th-15th Century stone work within the eastern range of the Stables.

Within the fabric of the eastern range of the stables there are the remains of a 14th - 15th century structure, possibly relating to the third castle at Nether Pollok. Figure 2 shows the external aspects of this feature. The structure to the left of the image is the rear of the modern stabling area within the complex, which was constructed in the mid-19th century and altered in the late 19th to early 20th century. The narrow stringer course is late 19th century in origin and is utilised to support the internal timbers of the roof above this section. While there is 19th century stone work within the fabric of this wall, these are purely for structural integrity into the earlier wall which is below the stringer course. This 11 course wall component is of an earlier building methodology as the block work here is not as regularised as the walls surrounding it or above it. In the centre right of this structure there is the remains of possibly an internal window within the original building, which is now partially blocked up with an internal wall to support the stringer course above it. The re-use of stone from this site throughout the Stables, specifically in the south and western ranges, and the limited amount of surviving stonework in the condition displayed here makes it difficult to ascertain the exact function these remains.

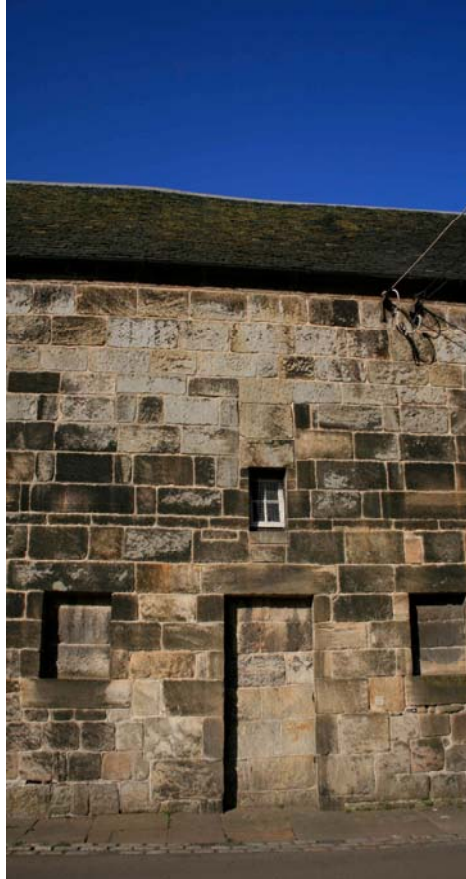
Figure 3

Possible late 17th or early 18th century cottage within the southern range of the Stables. The blocked three windows on the upper storey are still visible. With the central one being the three course directly above the modern 4 pane window visible in the centre of the image.

southern aspect of the range. The second phase of changes to access into the building consists of the blocking of the lower windows and doorway but the door and window frames were left recessed during this phase. The building is displayed in figure 3, below.

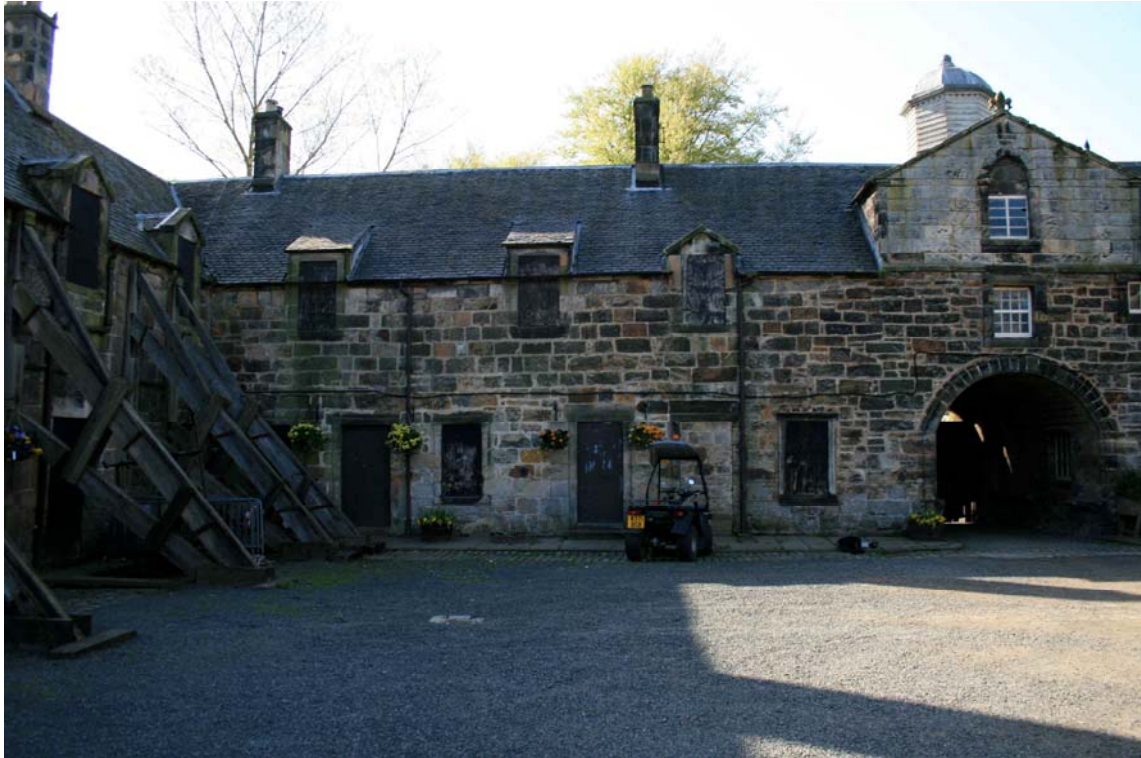
Figure 4

This image shows the internal elements of the western gatehouse and the now dilapidated section of the southern range

The timber supports in the left hand side of the image were erected in 1984 to strengthen the western end of the southern range which has been damaged by flooding from the White Cart, as well as wet and dry rot which has severely weakened the roof joists throughout this entire section of the range.

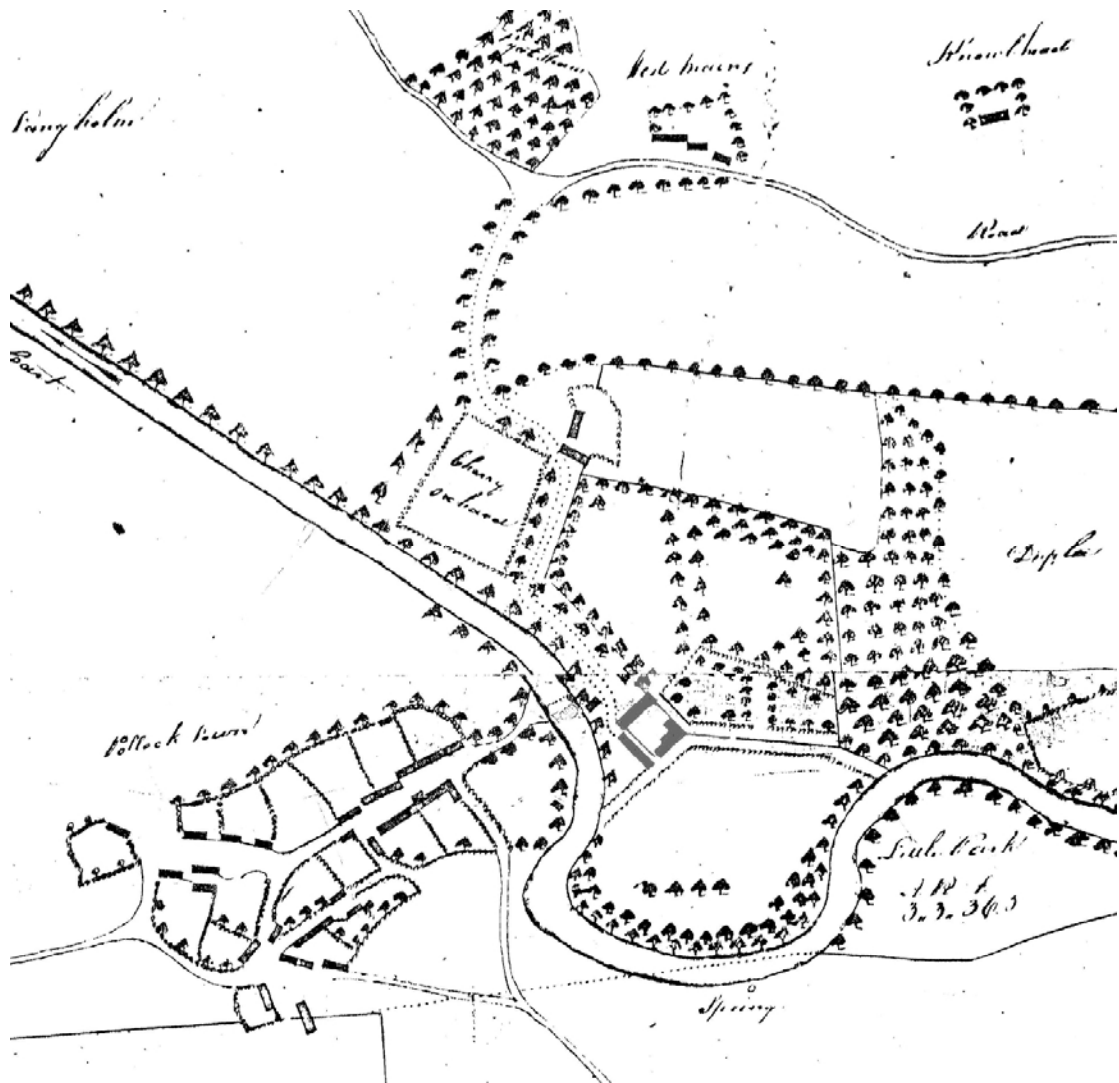
Figure 5

Enlarged section of Rober Ogilvy's 1741 estate map commissioned by the Maxwell family

The following maps and plans give an overview of the changes within the complex from the 18th century to the 21st century. The estate plan of Robert Ogilvy of 1741 below shows the Stables in grey against a black and white background. Ogilvy's estate plan was commissioned by Sir John Maxwell prior to the construction of the second Pollok House which occupies the area now entitled "Orchard" to the north west of the site. The compound consists of the gatehouse building, two retaining walls and the tower house or castle complex on its eastern side. To the west lies the village of Pollokton and to the north lies Knowehead Cottage at the top right of the illustration.

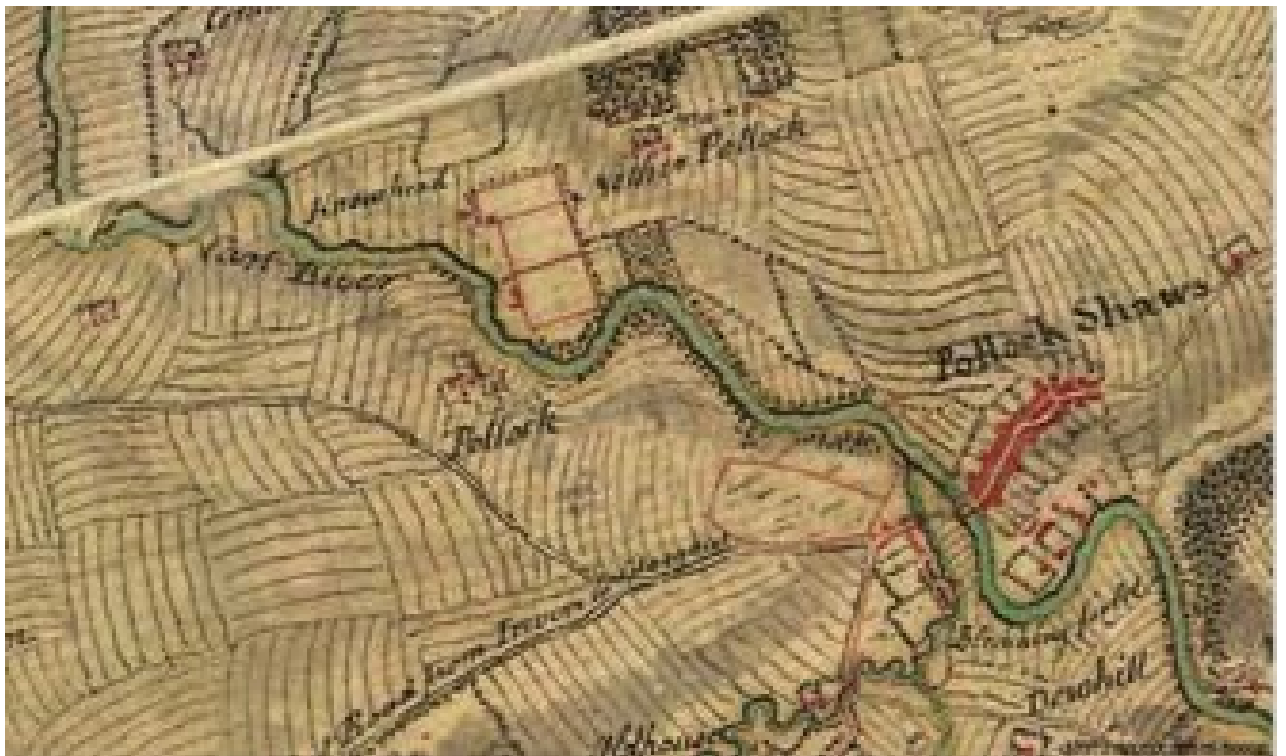
The image below represents an enlargement of General Roy's 18th century survey of the lowlands of Scotland. The Nether Pollok estate holdings of the Maxwells are clearly shown within this map segment. The village of Pollok or Pollok Toun is shown on the south side of the White Cart. Several buildings above the village are also clearly defined and these may well represent the buildings shown in Ogilvy's estate plan.

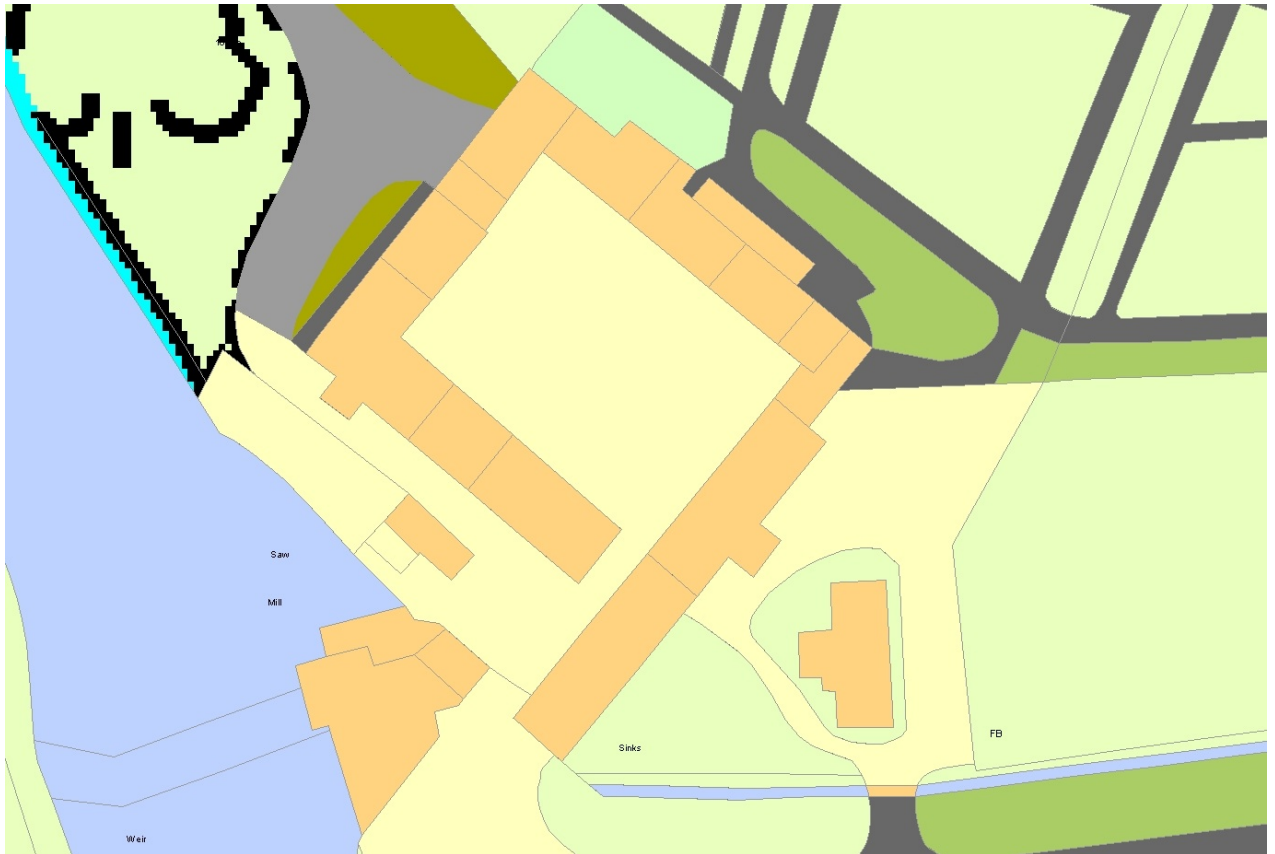
2008 OS 1:2500 land plan. This map shows the individual units of the Stables complex including the gardener's bothy and mill lade to the south east of the main range and the saw mill building complex on the banks of the White Cart water.

Figure 6 below shows the composition of the modern Stable complex. The most striking feature of the compound is that it still adheres to the layout of the ranges displayed in Figure 5, above, with minimal enhancements to the main building areas other than buildings being introduced into the fortified settlement to within the settlement to join the separate structures together.

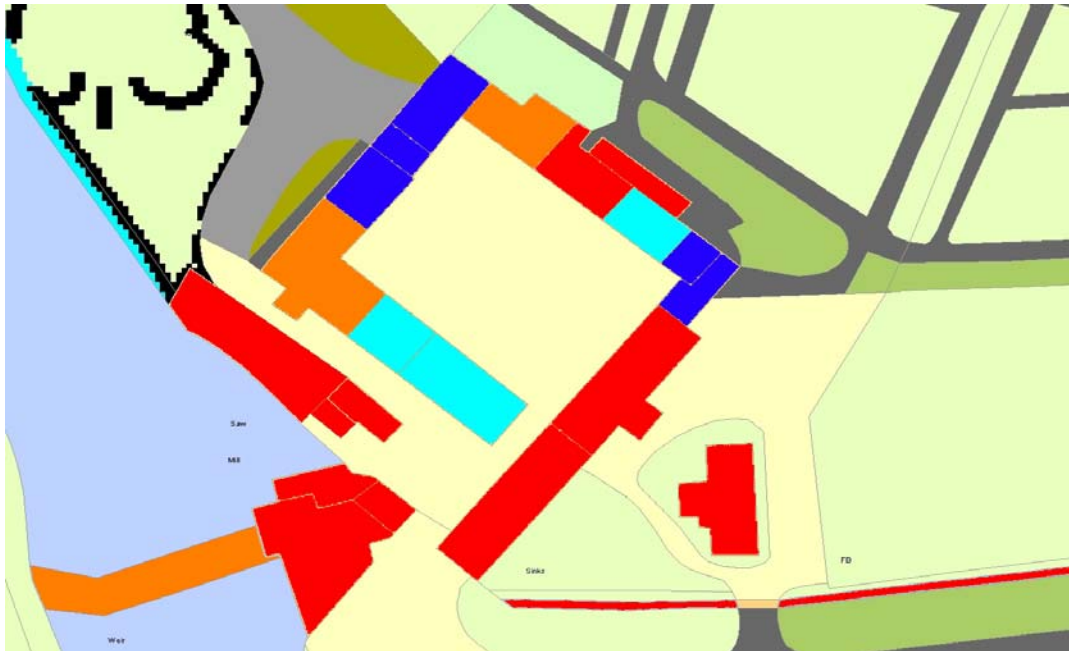
Figure 7 Copyright OS 2008

Figure 7 below represents an overview of the conjectural phases of construction which are identifiable from the standing buildings.

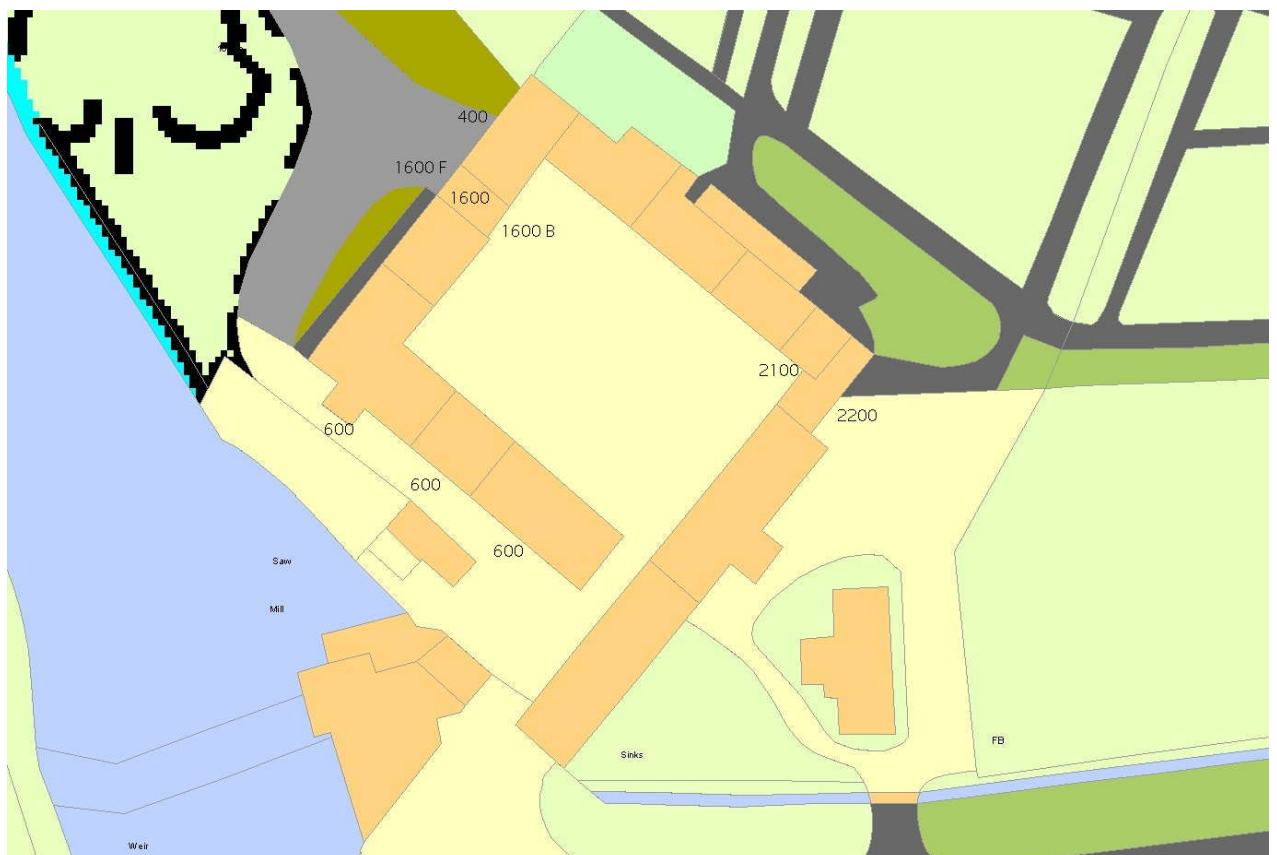
Figure 8 Copyright OS 2008
Annotated plan showing selected area numbers

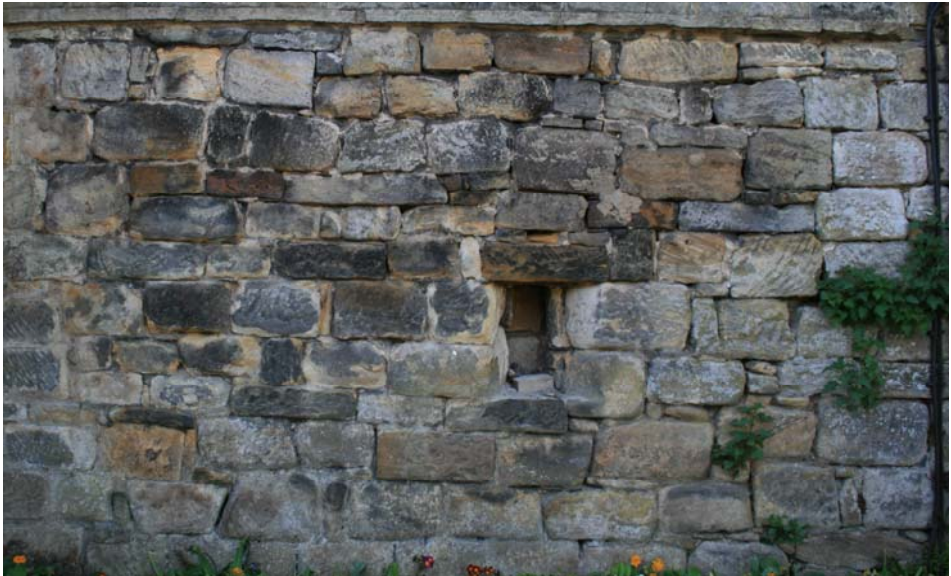
Area	2200
Context	4
Feature Type	ARROW LOOP
Dimensions	(External) 60 cm high by 59 cm wide. (Internal) 55 cm high by 23 cm wide. Overall Depth 75 cm.
Analysis	Possible arrow loop which is now blocked by an internal wall. Depth of the wall appears to indicate that this feature positioned within the oldest material in the Stables complex is part of an internal wall possibly facing into the main entrance way into the building.
Photographic Enlargement

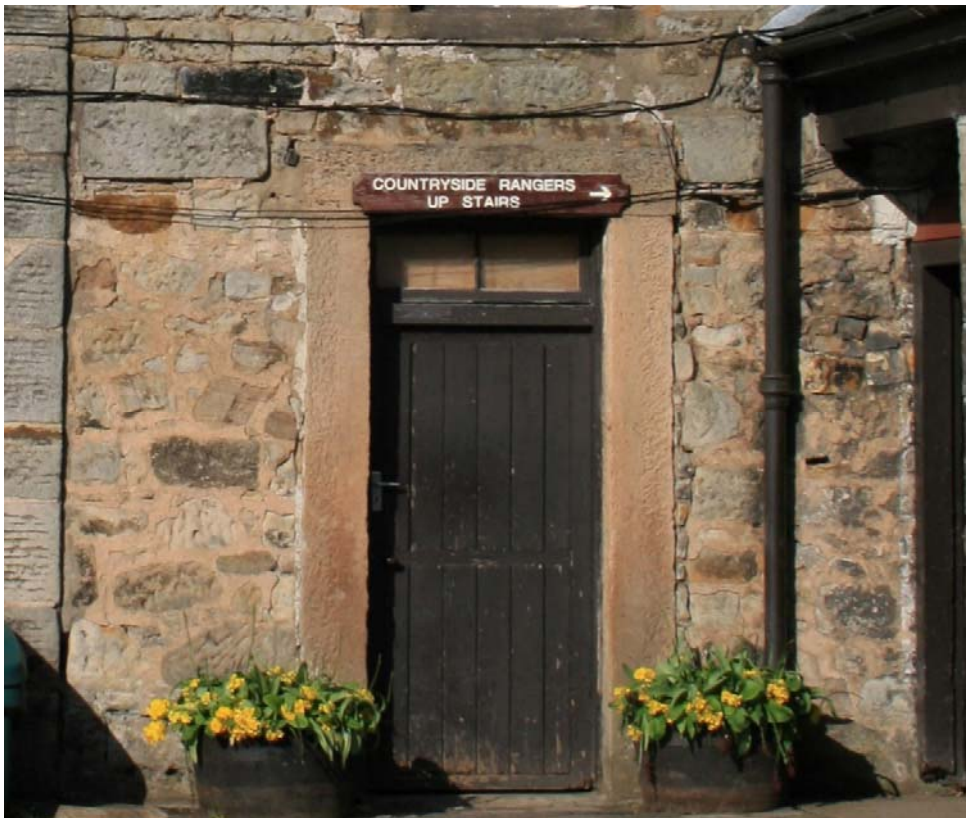
Area	1100
Context	32
Feature Type	LOWER RUBBLE WALL COURSE
Dimensions	Width 350 Cm Height 260 CM
Analysis	Roughly dressed lower rubble course of building. Part of the original tower house complex in the eastern range. Interface into 1743 built cottage indicates an earlier phas than the 18 th century as does a bricked up doorway in the entrance to the right of this photograph.
Photographic Enlargement

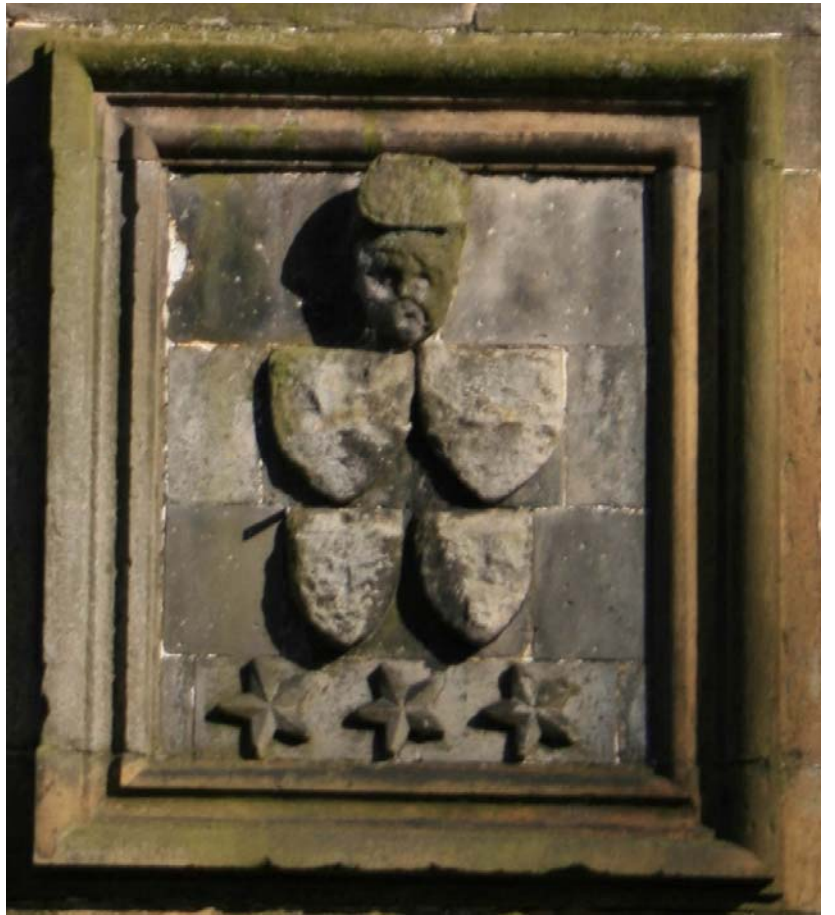
Area	1600F
Context	5
Feature Type	Coat of Arms
Dimensions	HEIGHT 1.25 Meter approx WIDTH 1 Meter Approx
Analysis	Coat of arms which appears to show the Maxwells of Nether Pollok Crests over the three stars of the Douglas. The coat or arms is not in its original mounting as the sand stone used is a finer stone type than the Barrhead grit used elsewhere within the complex. One possible origin is the original tower house complex.

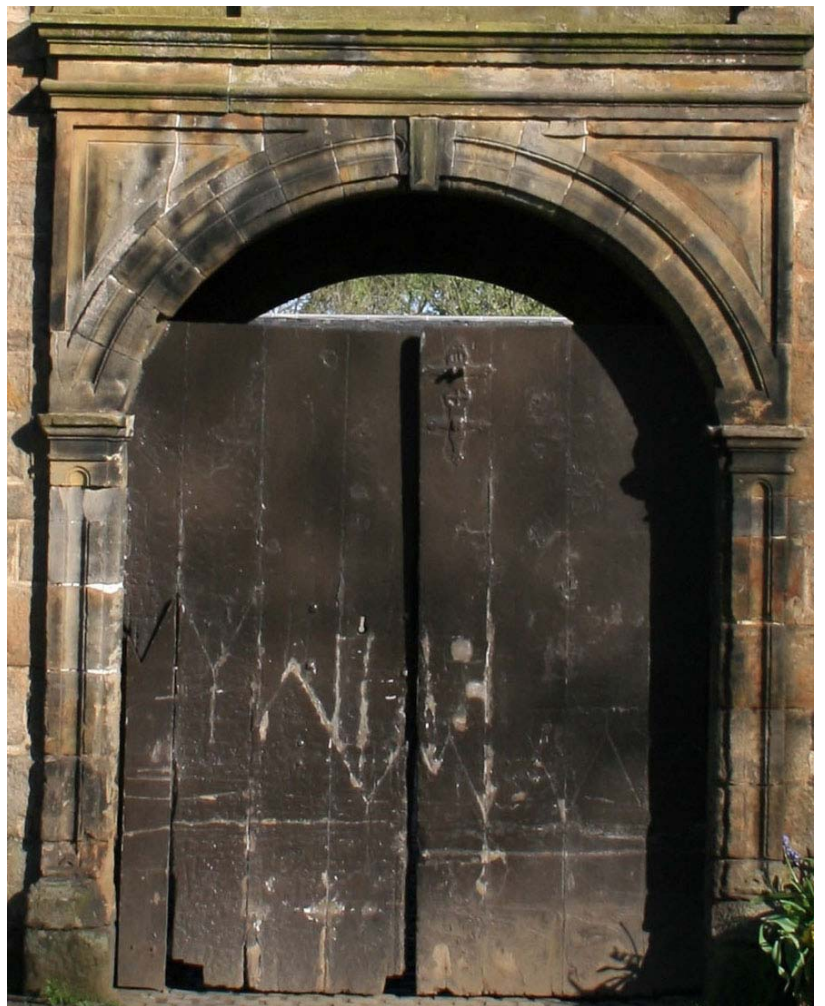
Area	1600 F
Context	7, 8 ,9, 10
Feature Type	STONE ARCHED FRAME
Dimensions	HEIGHT 3.75 Meters including Lintel WIDTH 3.05 Meters
Analysis	Stone façade covering or replacing the earlier original archway entrance. Stone utilized is again the Barrhead grit Variety. Lowest two courses , visible on the right hand side of the image below, have a decorative moulding which has been replicated in the newer façade.

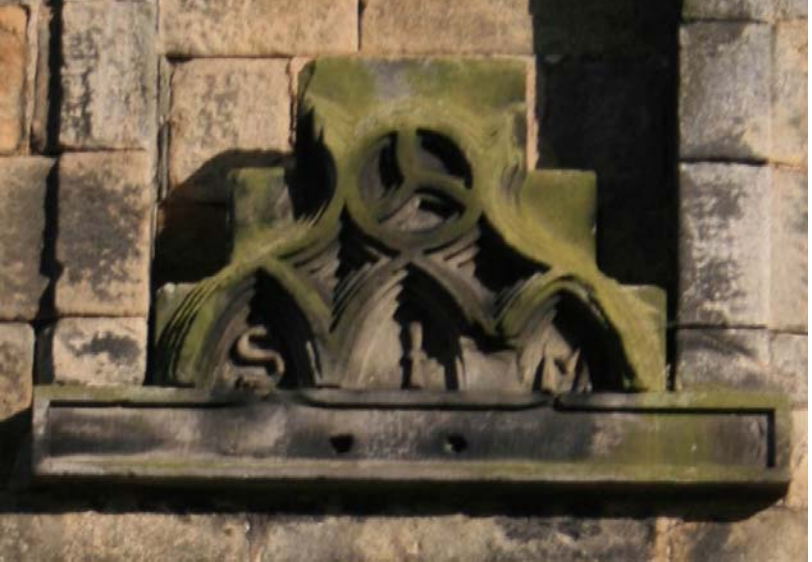
Area	1600 F
Context	4
Feature Type	ENGRAVED STONE
Dimensions	HEIGHT 50 CM WIDTH 75 CM
Analysis	<p>Fragment of a crow stepped decorated gable with the lettering SIM or Sir John Maxwell within three paned arches which also contain a four layer moulding. Placed within the 19th century extension to the Gateway complex in a recessed arch. This fragment has a similar three legged cross design at its apex to the one displayed above the entrance way to Higgs Castle and the moulding and design appear to be concurrent with that architectural style. This feature may have been recovered post the 1882 destruction of the tower house in the eastern range of the Stables.</p>
Photographic Enlargement

<p>The photograph shows a close-up of a stone fragment with a decorative archway. The arch is divided into three sections by two vertical lines. At the top center of the arch, there is a three-legged cross or fleur-de-lis design. The stone is weathered and has some greenish moss or lichen growth on its surface. The fragment is set against a background of other stone blocks.</p>

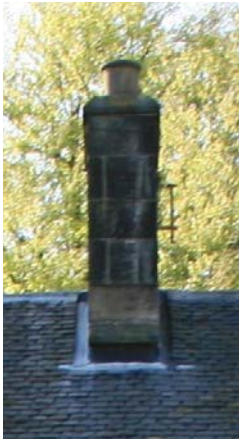
Area	600
Context	14
Feature Type	CHIMNEY STACK
Dimensions	Height 1.75 – 2 meters estimate Width 50 cm estimate
Analysis	19 th century chimneys stack with 20 th century chimney pots. 3 – 4 course construction. Stone utilized appears to be Barrhead Grit. Multiple examples throughout the Stables roofline. Angled step at the base of the stack indicates that the entire roof was thatched at an earlier period prior to the introduction of the slate roof visible in the image below.
Photographic Enlargement
